PREPARED FOR CITY OF MARION, NORTH CAROLINA

# CLINCHFIELD BASIN COLLECTION SYSTEM CONDITION ASSESSMENT REPORT

August 30, 2022

## **CITY OF MARION SEWER COLLECTION SYSTEM**

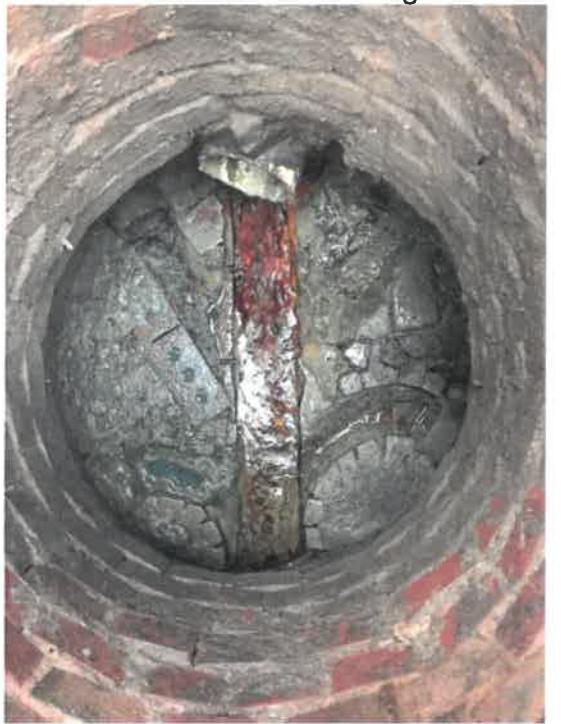
Manhole SSMH-1630 – Missing Mortar – Mud Infiltration

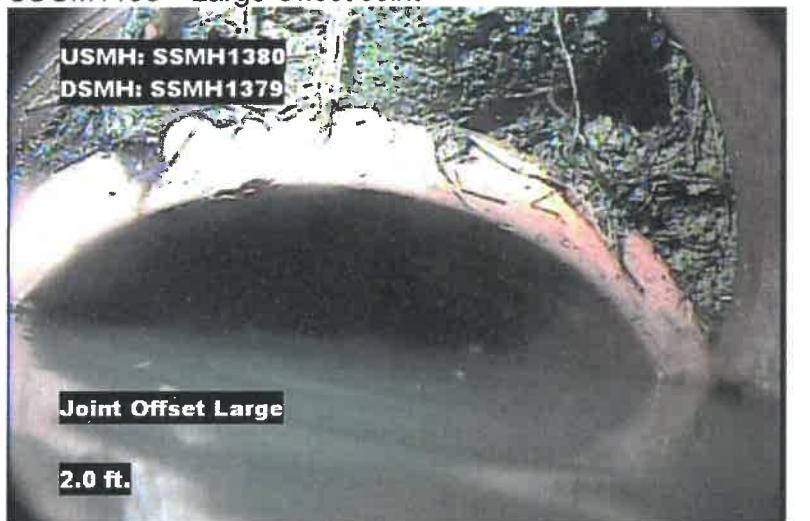
SSGM1198	SSMH1380	SSMH1379	BRANCH ST	Vitrified Clay Pipe	8	47	None	Large offset joint @ 46' with soil visible, Abandon survey @ 46'	5	Point Repair 46'-60', Install 8" CIPP Liner
SSGM1198	SSMH1380	SSMH1379	BRANCH ST	Vitrified Clay Pipe	8	2	Turn Around	Large offset joint @ 2' with soil visible, Abandon survey @ 2', Abandon survey @ 2'	5	See above
SSGM1270	SSMH1649	SSMH1415	BRANCH ST	Vitrified Clay Pipe	8	13	None	Material Change to PVC 2'-13', Large offset joints @ 2' and 13', Abandon survey @ 13'	5	Point Repair 0'-13', Install 8" CIPP Liner
SSGM1270	SSMH1649	SSMH1415	BRANCH ST	Vitrified Clay Pipe	8	197	Turn Around	Material change to DIP 37'-197', Corrosion/tuberculation in metal pipe, Intruding tap @ 64', Alignment change left @ 81', large offset @ 197', Abandon survey @ 197'	5	Install 8" CIPP Liner
SSGM1272	SSMH1415	SSMH1413	BRANCH ST	Vitrified Clay Pipe	8	99	Fine roots in joint @ 57'	Large offset joint @ 16', Material Change to DIP 24'-43', Surface Corrosion in metal pipe, Coating delaminating in metal pipe	3	Point Repair 14'-18', Install 8" CIPP Liner

SSGM1198 – Large Offset Joint

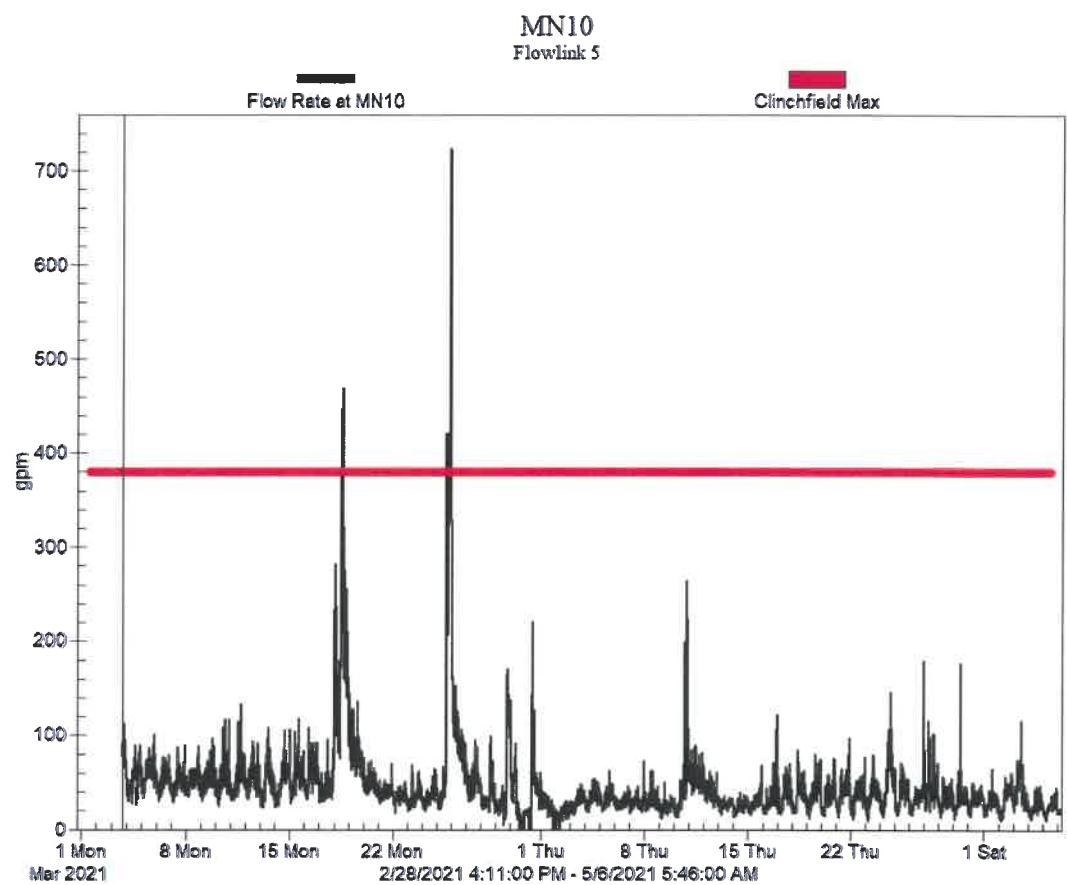
#### GRAPH 1: CLINCHFIELD INFLOW VERSUS MEASURED CAPACITY

As shown in Graph 1, flow into the Clinchfield pump station only exceeded the capacity of the pump station during the two major rain events observed during the monitoring period. Flow did not exceed the pumping capacity during minor rain events or during normal dry weather flow conditions. Based on this, we feel that this is more of an I-I problem than a pumping capacity problem and eliminating I-I through rehabilitating the collection system will reduce overflows in the Clinchfield basin.
