*Marion*  
North Carolina

DBD

<b>Maps:</b>	Map 01: Study Area Context .....	16
	Map 02: Regional Trail Network.....	17
	Map 03: Marion Peavine Trail.....	19
	Map 04: Marion Peavine Rail Trail Study Area ...	39
	Map 05: Recommendations - Section 1 .....	43
	Map 06: Peavine Cemetery Connections.....	53
	Map 07: Recommendations - Section 2.....	61
	Map 08: Passive Park & Mixed-use Redevelopment Opportunities .....	67

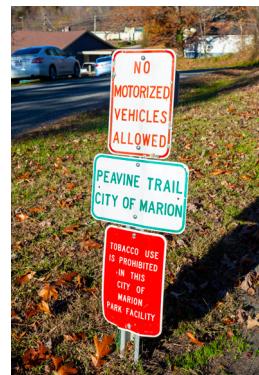
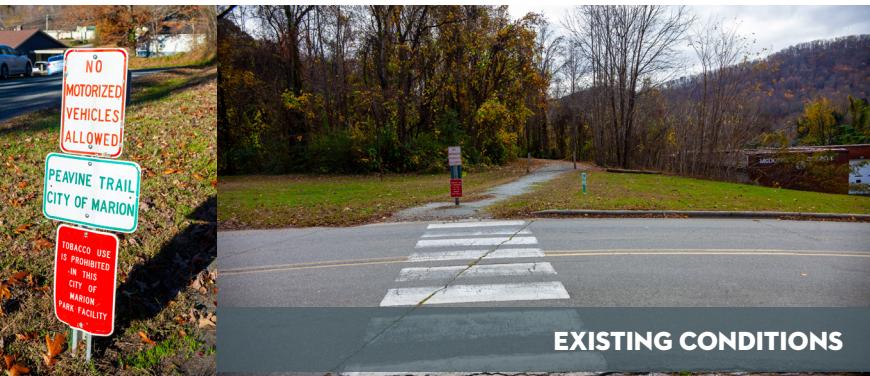
The typical existing road crossing on the Peavine Rail Trail includes a DOT high visibility crosswalk, plastic chain stretched between two posts, and regulatory signage. A standard road crossing should include elements that enhance safety for trail users and increase awareness of the trail for drivers.

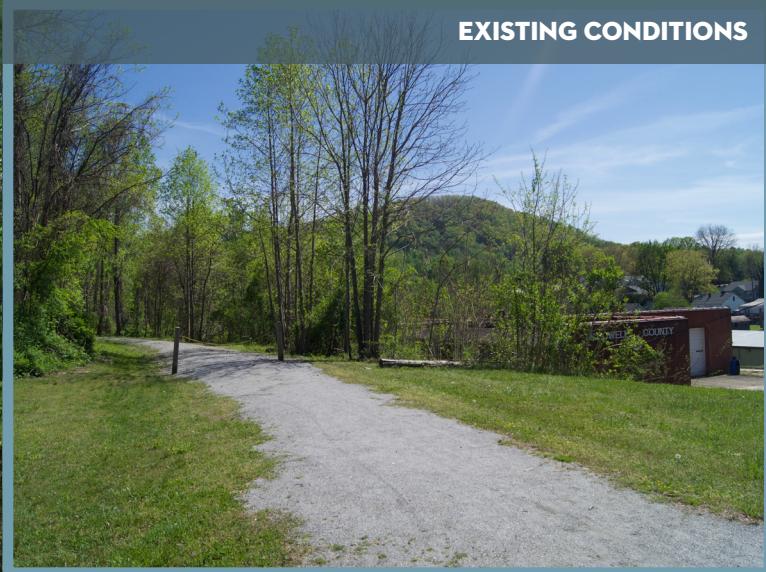
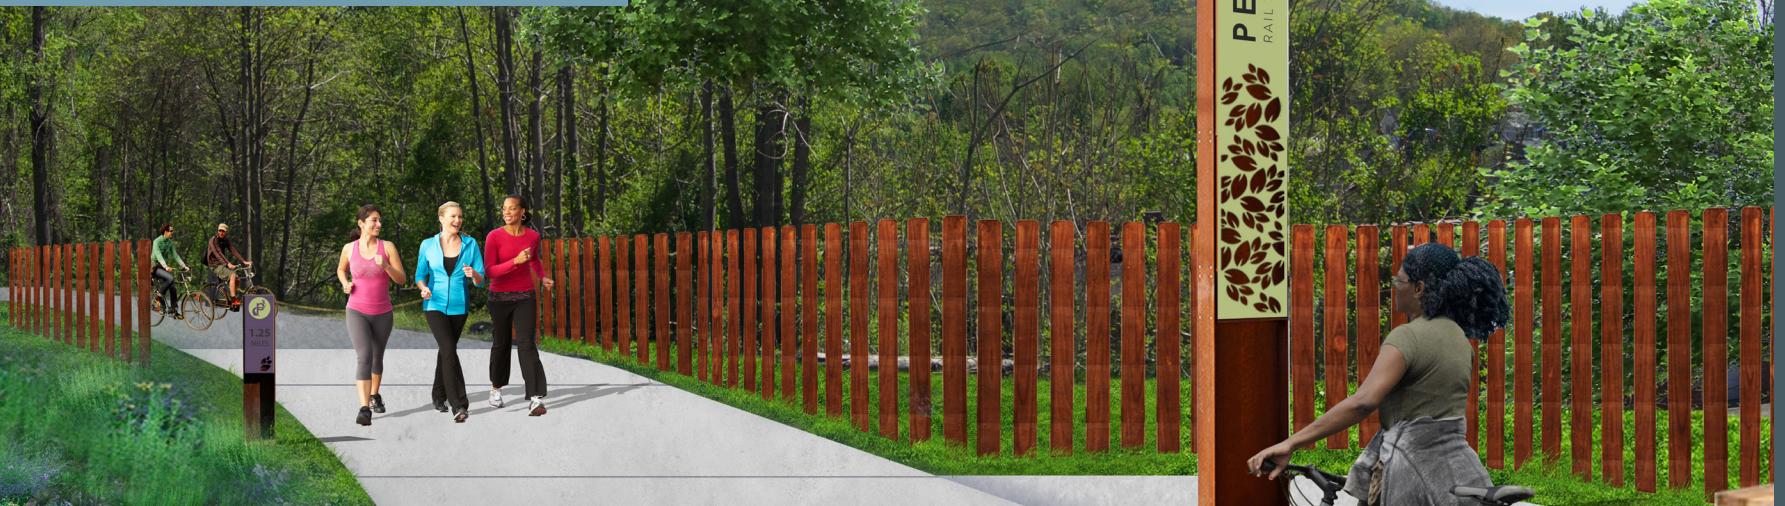
The Peavine Trail enters the old railroad corridor at its intersection with State Street. A formal trailhead on adjoining property at this location will provide access to the northern end of the rail trail and provide an information kiosk, connector trail, and parking.

*The State Street Trail  
Entrance will include a  
trail monument, fencing,  
mile marker, benches, and  
paved entry to the trail.*

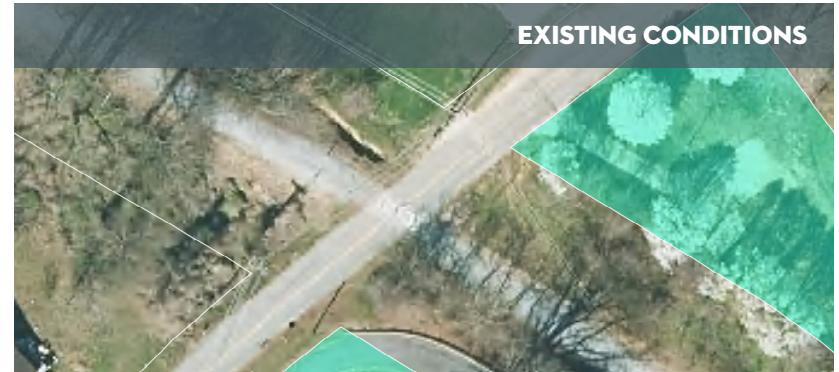
### EXH 07: GEORGIA AVENUE/MOREHEAD ROAD TRAIL CROSSING

The Peavine Trail approaches Oak Grove and Morehead Cemeteries at the Georgia Avenue/Morehead Road crossing. A small seating area, interpretive waysides, and memorial will provide trail users with a contemplative resting area.

*A seating wall will give trail users a temporary resting place and interpretive signs will present trail users with information about the history of Morehead Cemetery. A sidewalk will provide a safe connection to the Morehead Cemetery entrance.*

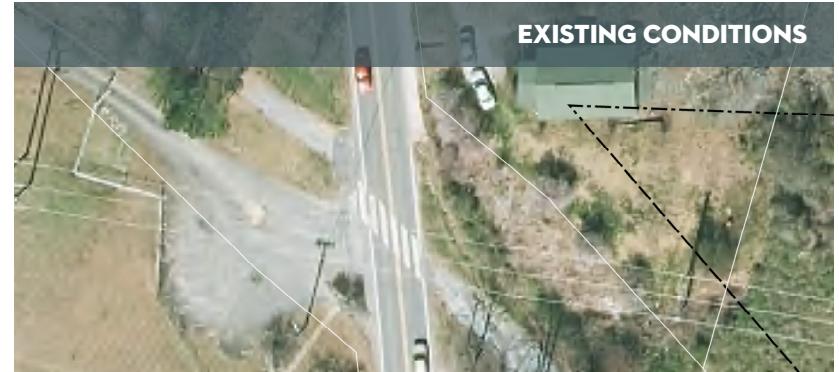
### EXH 09: BALDWIN AVENUE CROSSING

Baldwin Avenue represents one of the busiest road crossings along the trail. A small parking area and substation access road is located on Duke Energy property to the southwest of the trail. This crossing location will be ideal for a formal trailhead on adjacent property.

*The Baldwin Avenue crossing will feature trail monuments, mile marker, and fencing to provide a consistent branded identity for the trail.*

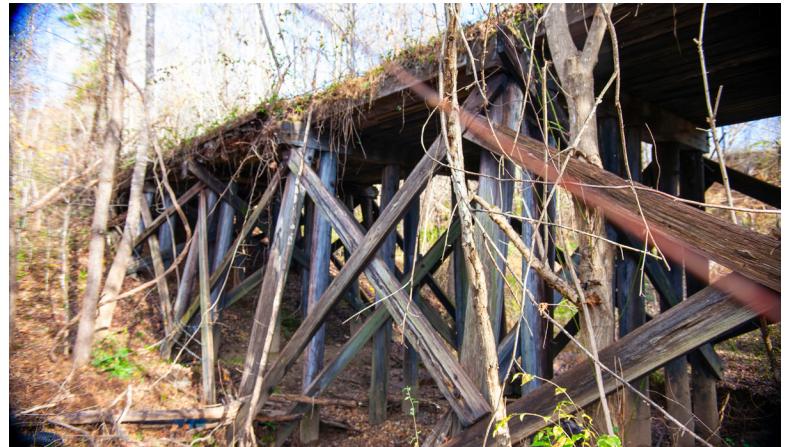
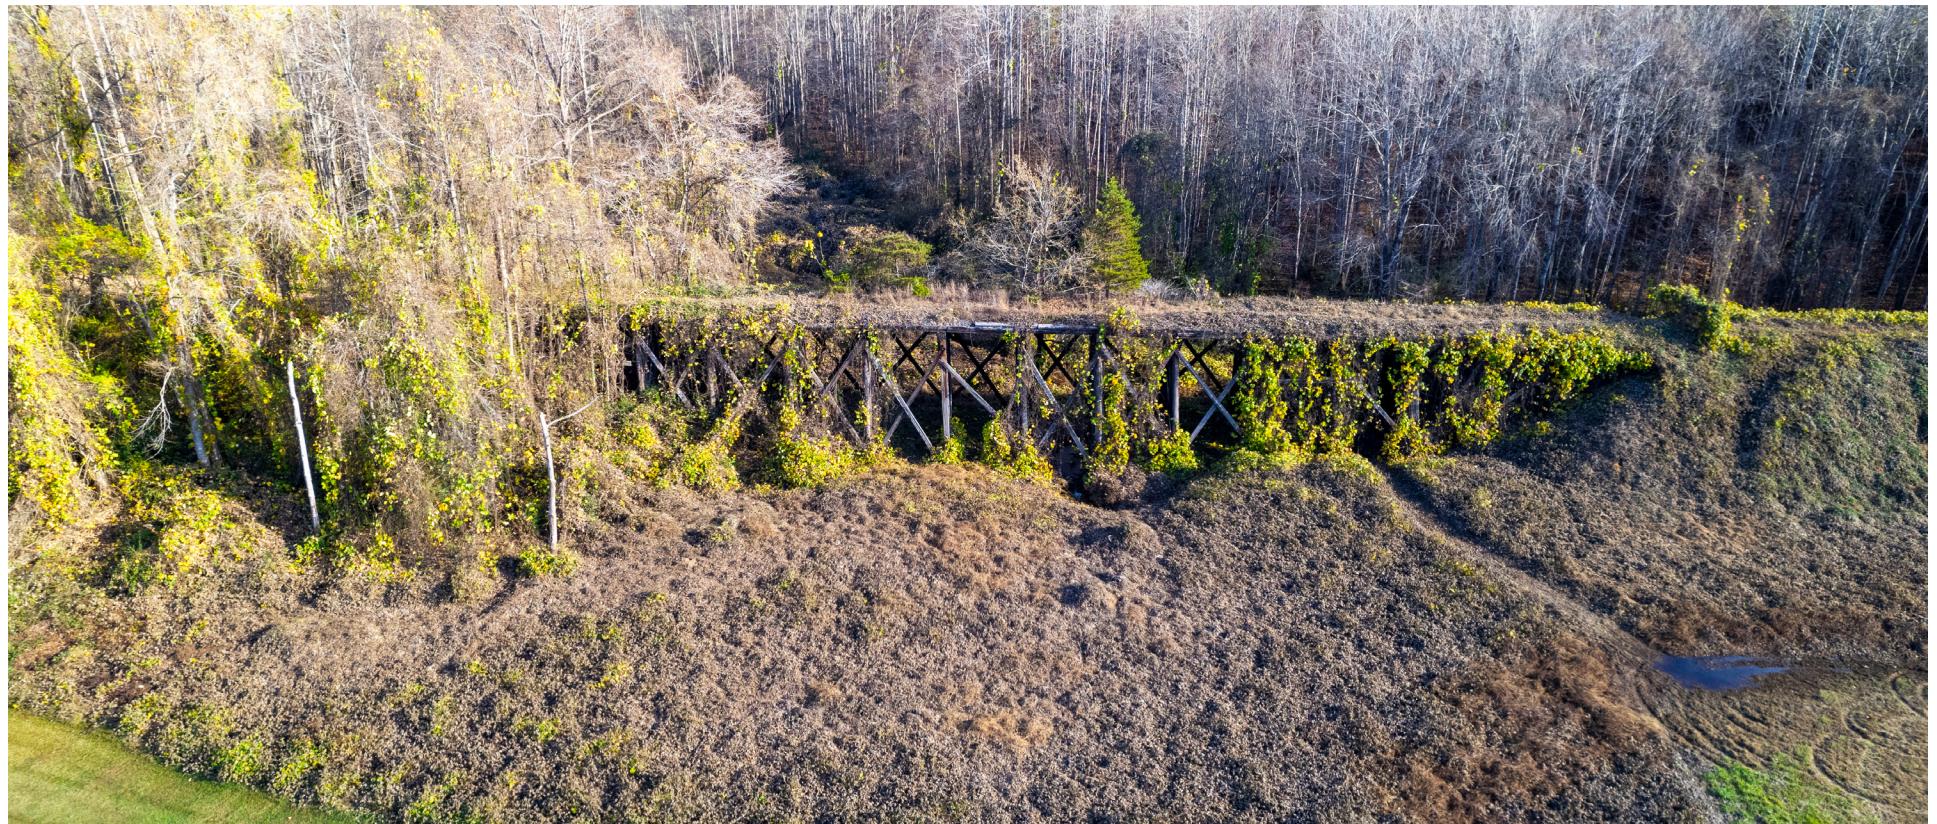
On this section of the proposed trail, there are two abandoned railroad trestles that cross small streams. The northern trestle is approximately 300 feet long and the southern trestle is approximately 150 feet in length. The trestles offer unique points of interest along the Peavine Rail Trail that provide a reminder of the history of the railroad corridor. The trestles will be modified and repaired to keep their historical look and provide safe passage for trail users.

*In January 2019,  
the City of Marion  
contracted with  
Kimley-Horn to  
conduct the Peavine  
Trail Trestles Feasibility  
Study and evaluate the  
two existing trestles for  
conversion into pedestrian  
bridges.*

*The consultant determined that both trestles have significant foliage overgrowth, and in many areas, exterior beams are deteriorated beyond repair and the timber is rotted. The study recommended and provided cost estimates for repurposing the existing trestles through a series of modifications and repairs. A cost estimate was also provided for demolishing the existing trestles, rerouting the trail, and utilizing shorter pedestrian bridges.*

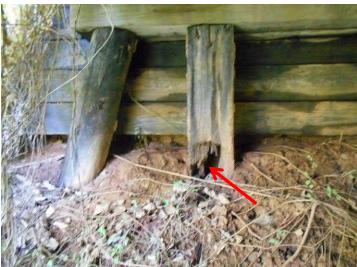
**Photo 1**  
Trestle One – General Elevation

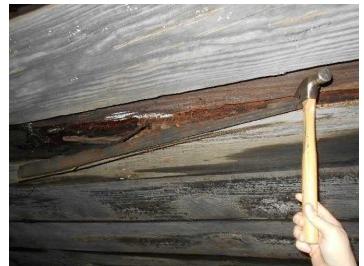
**Photo 2**  
End Bent Pile Decay

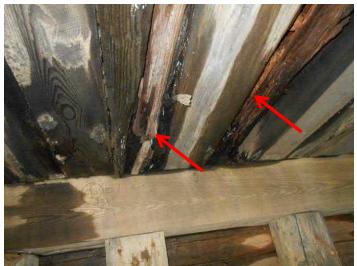
**Photo 3**  
Interior Beam Decay

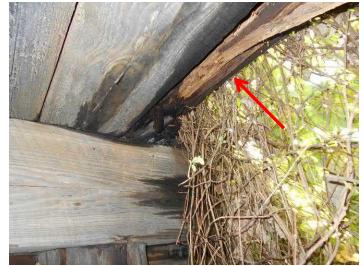
**Photo 4**  
Interior Beam Decay

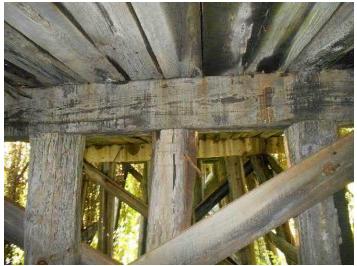
**Photo 5**  
Decayed/Damaged Exterior Beam

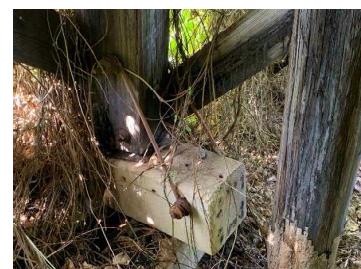
**Photo 8**  
Concrete Bent Cap

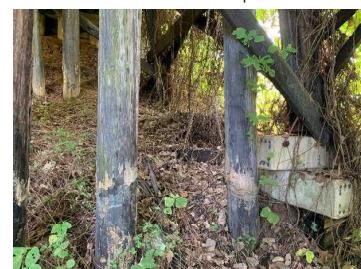
**Photo 9**  
Bent 3 Major Pile Repair

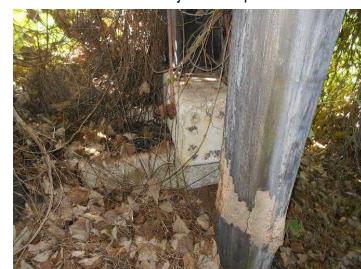
**Photo 10**  
Bent 3 Major Pile Repair

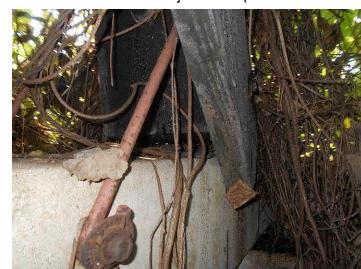
**Photo 11**  
Bent 3 Major Pile Repair

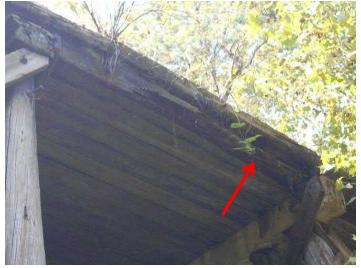
**Photo 16**  
Failed Exterior Beam

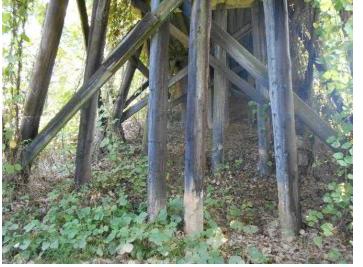
**Photo 17**  
Typical Interior Bent

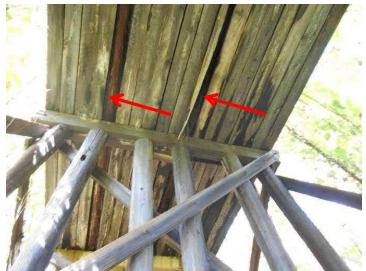
**Photo 25**  
Damaged Interior Beams

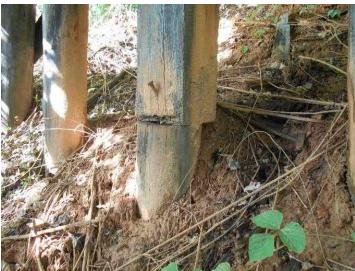
**Photo 26**  
Typical Pile Modification

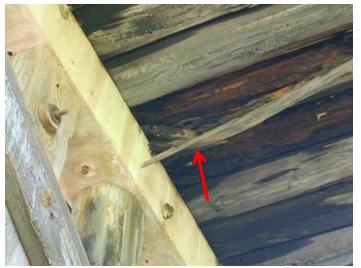
**Photo 27**  
Damaged Interior Beam

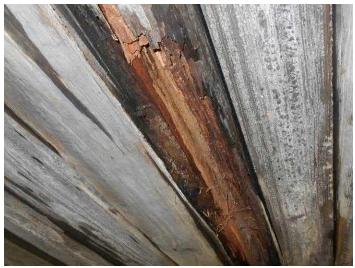
**Photo 28**  
Interior Beam Decay

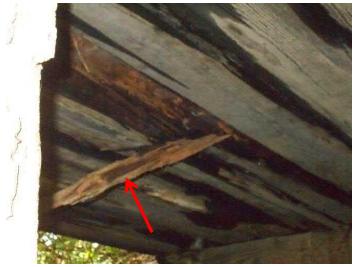
**Photo 29**  
Damaged Interior Beam

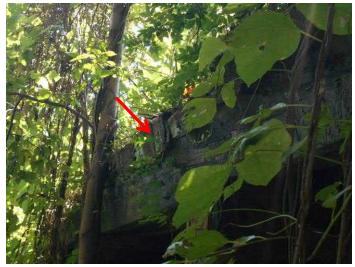
**Photo 30**  
Rotated Exterior Beam

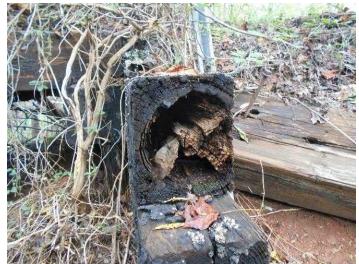
**Photo 40**  
End Bent Backwall Decay

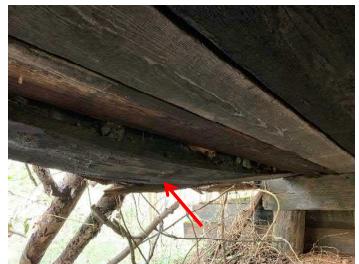
**Photo 41**  
Failed Exterior Beam

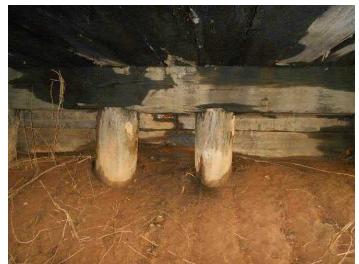
**Photo 42**  
Typical End Bent Backwall Elevation

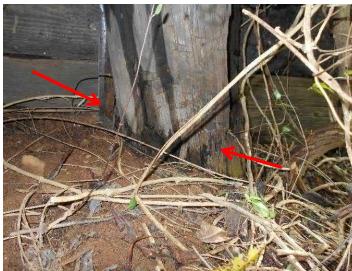
**Photo 43**  
Damaged Timber Pile

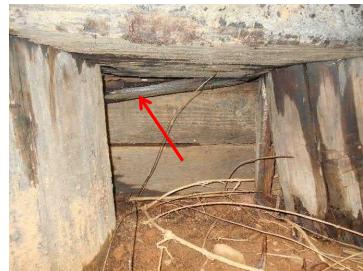
**Photo 44**  
Damaged Timber Cap

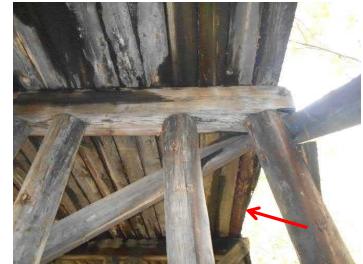
**Photo 46**  
Exterior Beam Decay

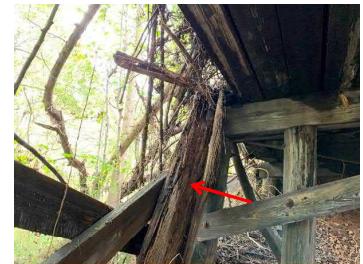
**Photo 48**  
Completely Failed Exterior Beam

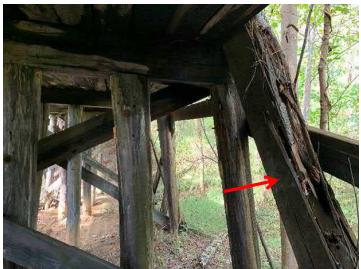
**Photo 49**  
Completely Failed Exterior Beam

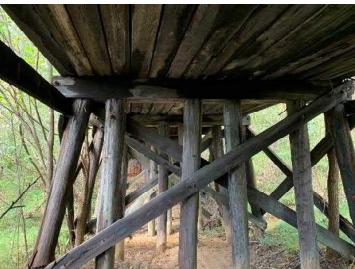
**Photo 50**  
Typical Interior Bent
