ANALYSIS OF BROWNFIELD CLEANUP ALTERNATIVES – PRELIMINARY EVALUATION

**U.S. EPA Brownfield
Cleanup Grant
Former Drexel Manufacturing Site,
70 Blue Ridge Street, Marion NC 28752
Brownfields Project Number 20072-16-056**

Prepared by the City of Marion

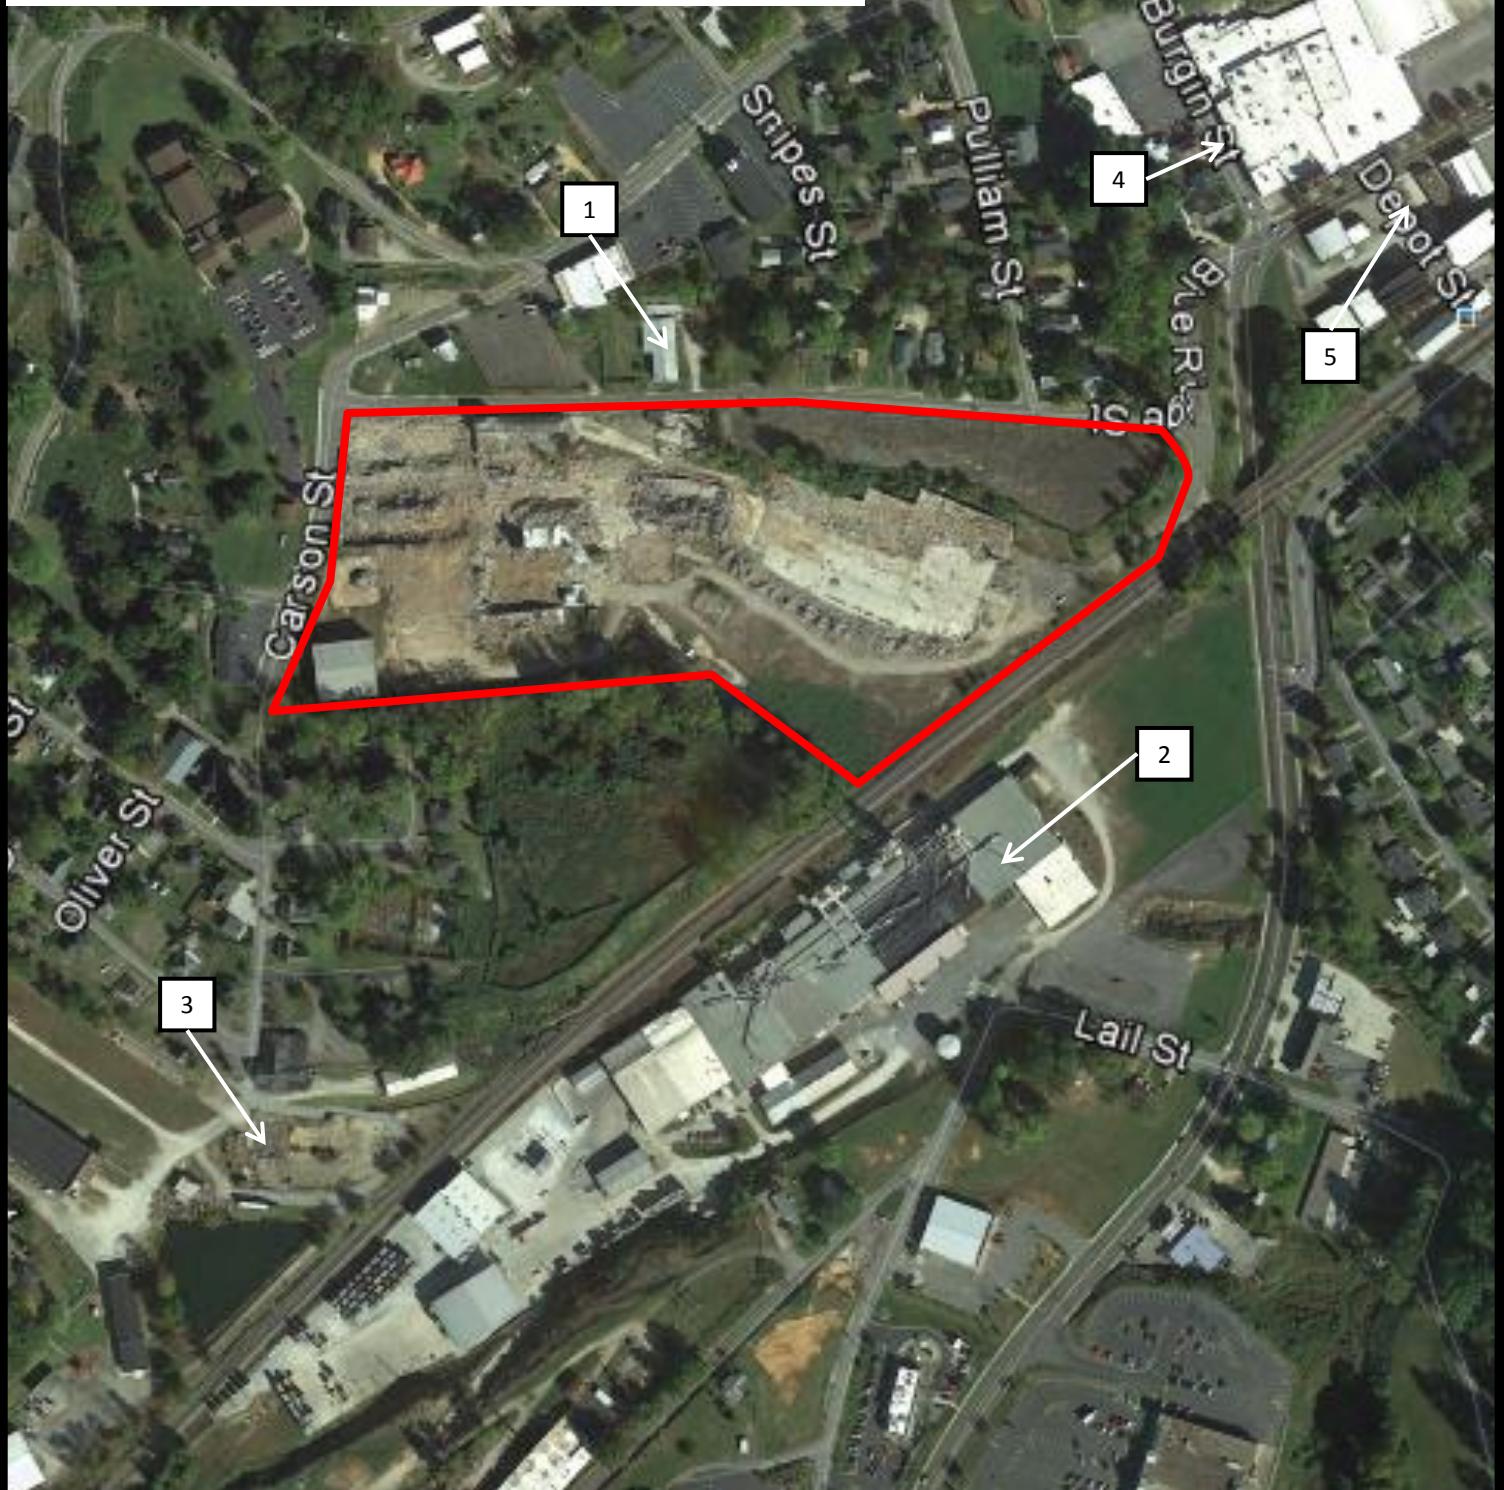
FIGURE 2
AERIAL MAP & OFF-SITE ENVIRONMENTAL CONCERN
FORMER DREXEL FACILITY
70 BLUE RIDGE STREET
MARION, McDOWELL COUNTY,
NORTH CAROLINA

- 1 EXISTING USTs & OWS
- 2 FORMER DIESEL UST
- 3 FORMER LACQUER THINNER UST
- 4 FORMER NAPHTHA UST
- 5 FORMER GASOLINE UST & FORMER SVE/AS SYSTEM
- 6 FORMER SOLVEN AST
- 7 OBSERVED DRUMS
- 8 OBSERVED DRUMS & STAINING
- 9 FORMER DRUM RACK
- 10 FORMER DRUM STORAGE
- 11 FUEL OIL BURIAL
- 12 REPORTED FREE PRODUCT SEEPAGE

- The presence of 15 UST or AST sites, within 0.25 mile of the Site, upgradient of the Site is considered a REC.
- The presence of an automotive repair property 0.03 mile north of the Site at a higher elevation is considered a REC.

- The presence of a dry cleaner 0.14 mile northeast of the Site at a higher elevation is considered a REC
- Fluorescent light bulbs and fixtures were observed throughout the Site building. The fluorescent light bulbs appeared to be in good to poor condition, but their age is unknown. Older fluorescent light bulbs may contain PCBs and mercury. Based on a potential presence of PCBs and mercury, the fluorescent light bulbs may represent a REC.

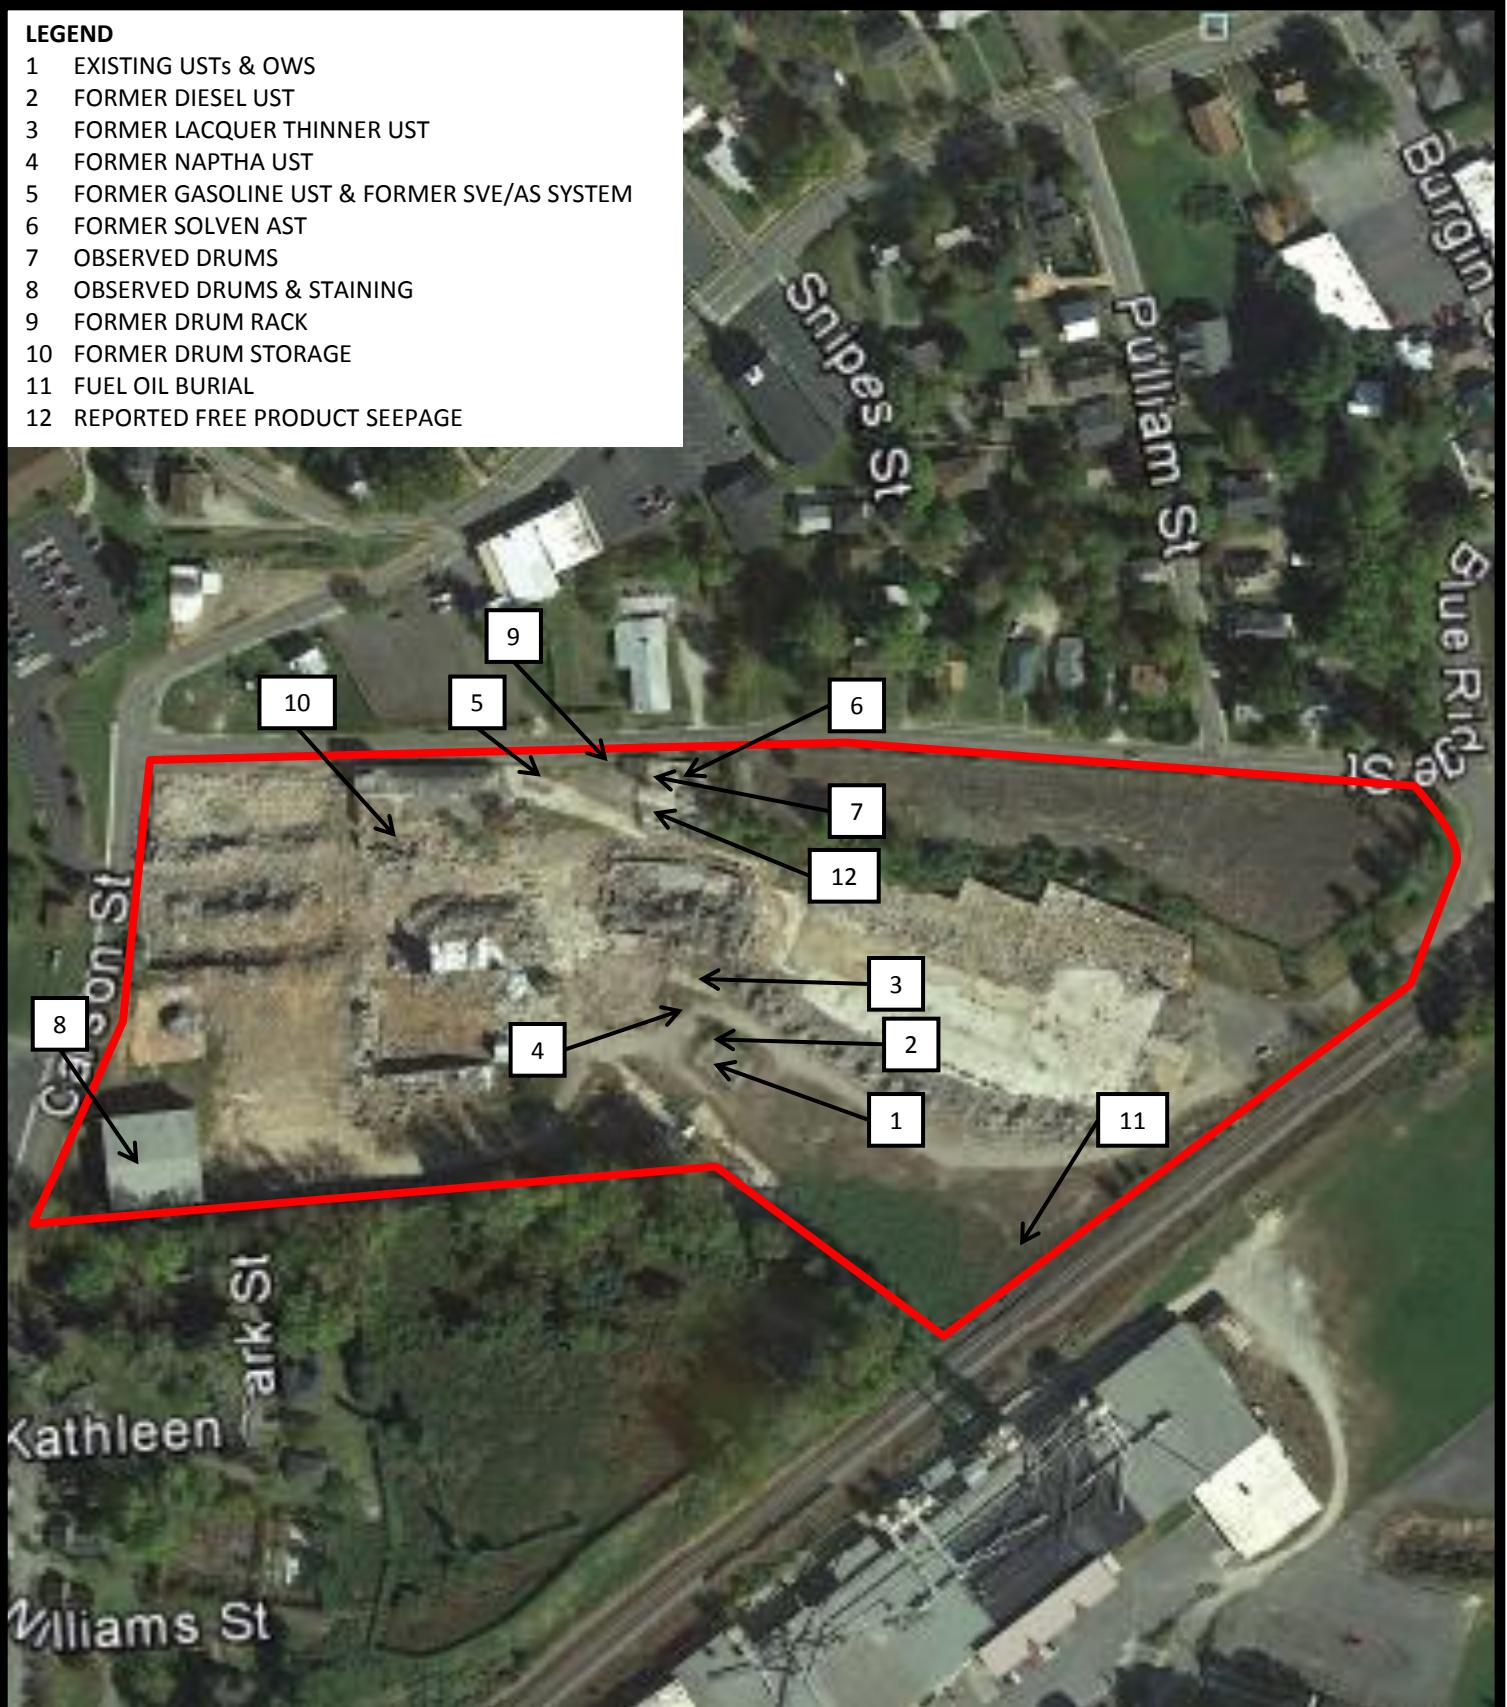
FIGURE 3
SITE DETAIL MAP & ON-SITE ENVIRONMENTAL CONCERNS
FORMER DREXEL FACILITY
70 BLUE RIDGE STREET
MARION, McDOWELL COUNTY,
NORTH CAROLINA

● PROPOSED SOIL SAMPLE LOCATION

- The presence of the fuel oil UST on the Site is considered a REC.
- The presence of an oil-water separator on the Site is considered a REC.
- The presence of the additional USTs or former ASTs on the Site is considered a REC.

- The aluminum-clad steel frame building with numerous 55-gallon drums and smaller containers is considered a REC.
- The other onsite brick building that contained 55-gallon drums located along Blue Ridge St. east of the office building is considered a REC.

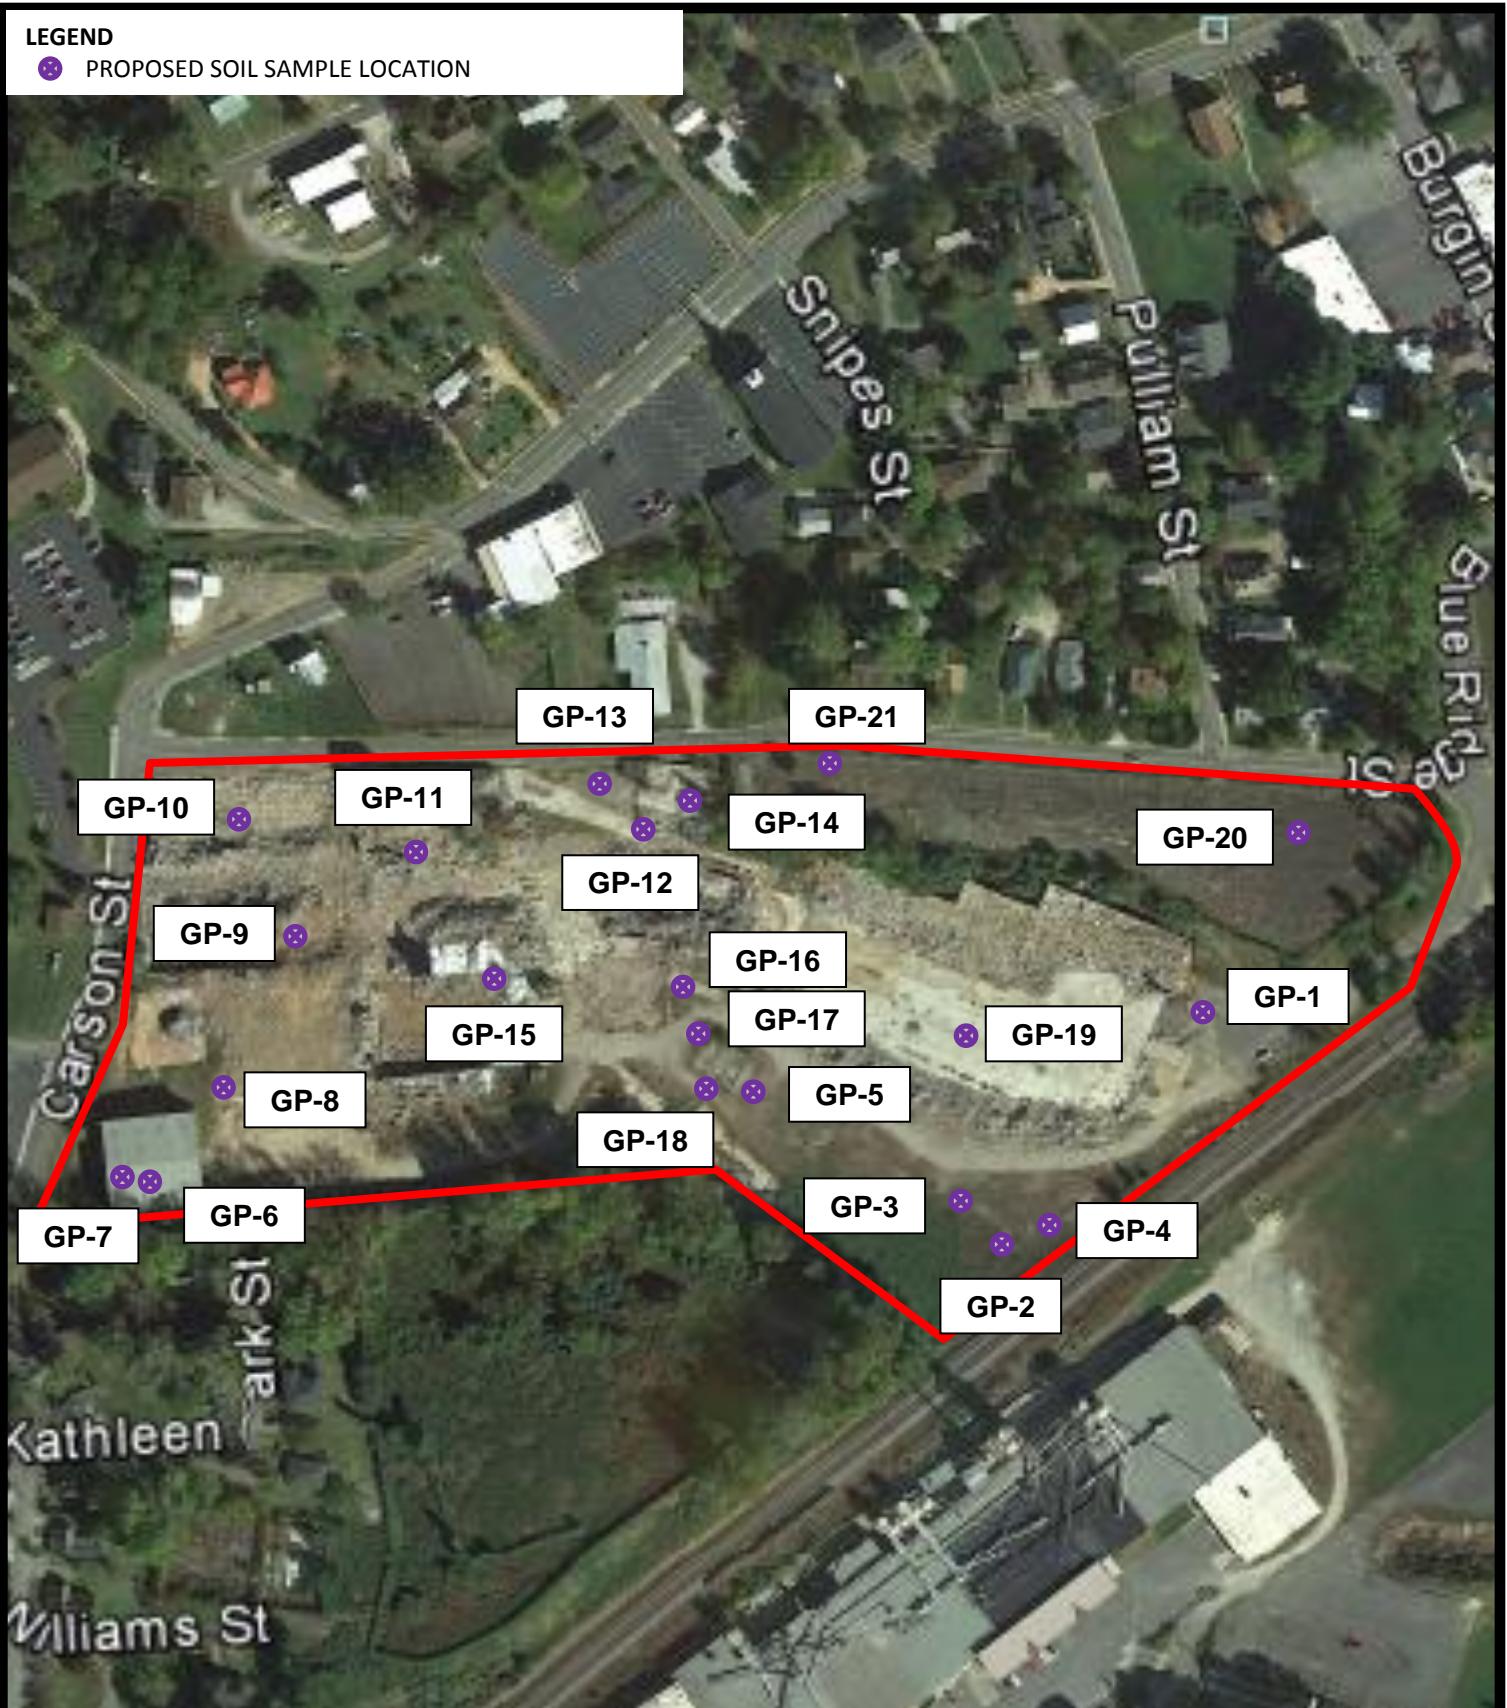
FIGURE 4
SOIL SAMPLE LOCATION MAP

PROPOSED GROUNDWATER SAMPLE LOCATION

- A total of 21 soil borings were advanced for the collection of soil samples and a total of 12 permanent monitoring wells were installed for the collection of groundwater samples. The soil borings and monitoring wells were placed to assess previously identified potential environmental concerns.
- Laboratory analysis of soil sample GP-5, which was collected in the vicinity of the USTs and OWS located on the central portion of the subject property, detected several petroleum compounds. Benzo(a)anthracene was detected above its IHSB Protection of Groundwater PSRG, but below its IHSB Residential and Industrial/Commercial Health Based PSRGs. ECS concludes that a release(s) from the USTs and/or OWS has occurred.

- Laboratory analysis of soil sample GP-6, which was collected in the vicinity of drums and staining within the aluminum-clad steel frame building located on the southwestern portion of the subject property, detected several petroleum compounds. P-isopropyltoluene, naphthalene, 1-Methylnaphthalene, and 2-methylnaphthalene were detected at concentrations above their respective IHSB Protection of Groundwater PSRGs, but below its IHSB Residential and Industrial/Commercial Health Based PSRGs. ECS concludes that spills from drums within the building have impacted the soil beneath the building.

- Laboratory analysis of the soil samples detected several elevated concentrations of arsenic, chromium, and selenium. Analysis of background soil samples GP-20, GP-20D, and GP-21, collected from the northeastern portion of the subject property, detected arsenic, chromium, and selenium at similar concentrations as the samples collected on the remainder of the subject property. However, arsenic was detected in soil samples GP-7D and GP-8 at concentrations over 2.5 and 8 times the highest background soil sample concentration. These soil samples were collected from soil borings located within and in the vicinity of the aluminum-clad building located on the southwestern portion of the subject property. Chromium was detected in soil sample GP-19 at a concentration over 6 times the highest background soil sample concentration. This soil sample was collected from the soil boring on the former building pad located on the eastern portion of the subject property. These elevated concentrations are likely due to activities previously conducted at the former facility.

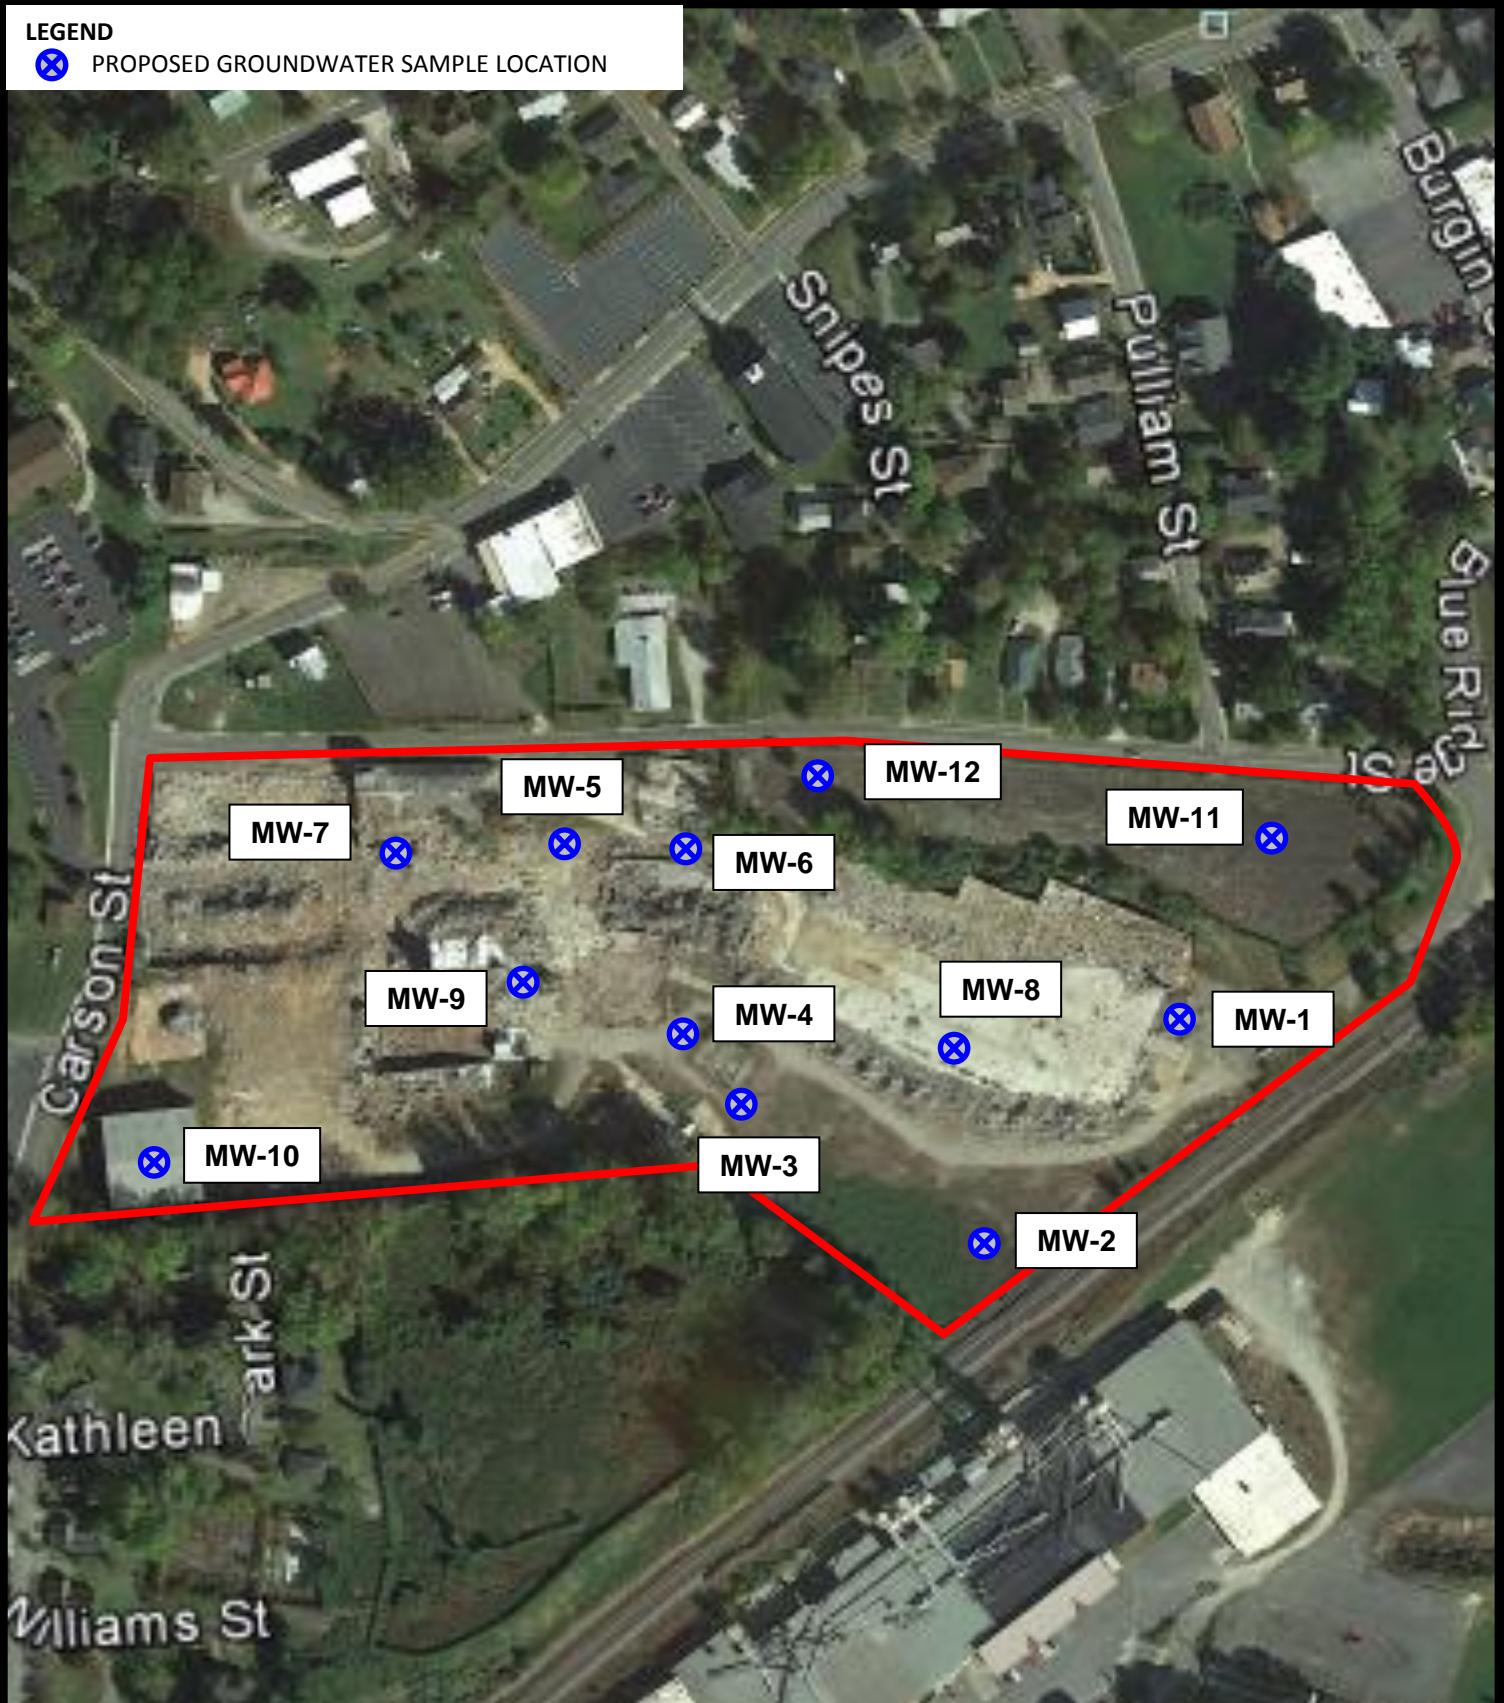
FIGURE 5
MONITORING WELL & GROUNDWATER SAMPLE
LOCATION MAP
FORMER DREXEL FACILITY
70 BLUE RIDGE STREET
MARION, McDOWELL COUNTY,
NORTH CAROLINA

- PROPOSED GROUNDWATER SAMPLE LOCATION
- ELEVATION CONTOUR
- GROUNDWATER FLOW DIRECTION

- Laboratory analysis of groundwater samples MW-5, which was collected on the northern portion of the subject property, downgradient of the former UST and SVE/AS system and former Willwear Hosiery Manufacturing Company, Inc., detected several petroleum compounds. Benzene, ethylbenzene, naphthalene, toluene, total xylenes, 1-methylnaphthalene, and 2-methylnaphthalene were detected at concentrations above their respective NC2LGWQSSs, but below their applicable GCLs. ECS concludes that remaining contamination is present from the former UST and/or the prior release from the Willwear Hosiery Manufacturing Company, Inc.
